ASSESSMENT OF DAM SAFETY OF COAL COMBUSTION SURFACE IMPOUNDMENTS

**Crisp County Power
Commission
Plant Crisp
Warwick, Georgia**

Prepared for
*U.S. Environmental
Protection Agency
Washington, D.C.*

November 2012

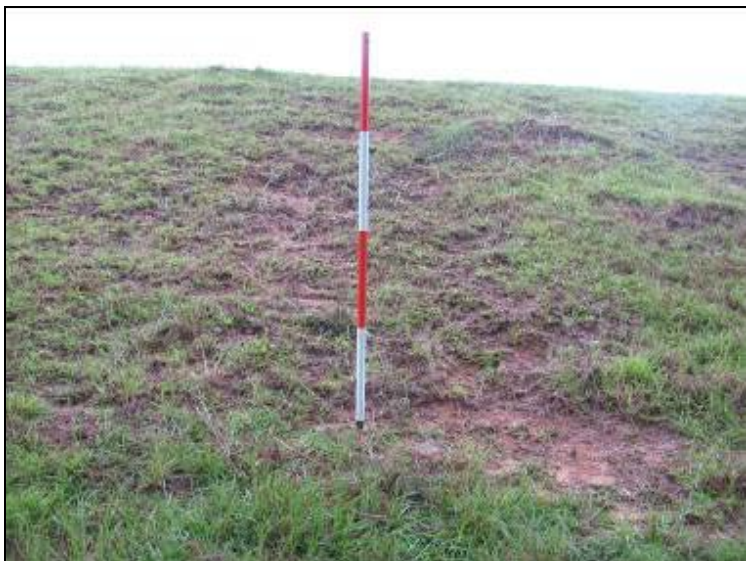
Photo 5: Ash Pond – North embankment exterior slope, minor surficial erosion looking south.

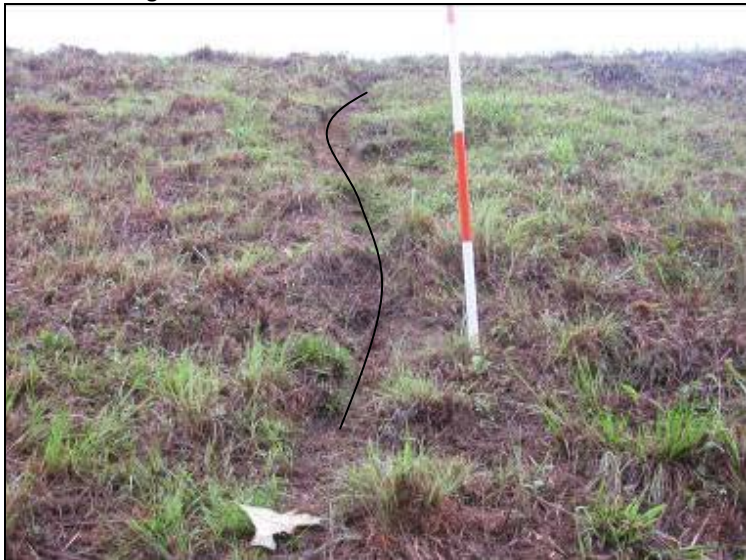
Photo 7: Ash Pond – North embankment exterior slope, surficial erosion rill running from crest to toe of slope looking south.

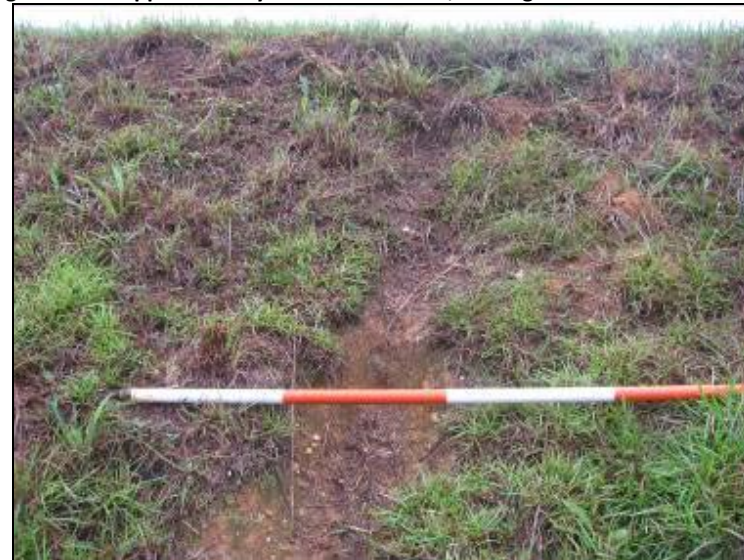
Photo 8: Ash Pond – North embankment exterior slope, erosion rill near crest, looking south.

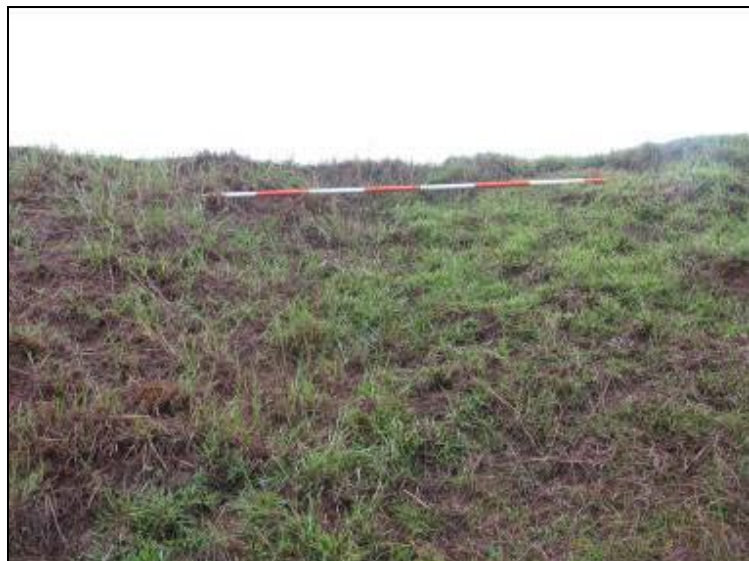
The exterior slopes appear to be in **FAIR** condition. The exterior slopes of the embankments vary from 2H:1V at the north and west embankments, 5H:1V at the south embankment and 4H:1V at the southeast embankment. The east portion of the north embankment has an approximate slope of 3H:1V with a slope break near the outlet structure to 2H:1V (Photograph 6). Slopes shown on the drawings provided are 3H:1V. The exterior slopes are covered with low height vegetation which was approximately 4 to 6 inches high at the time of the visual assessment (Photographs 14 to 17, 31, 32, 38, 39, 44 and 45). Surficial erosion rills and scarps were observed at the north embankment (Photographs 5, 7 and 8). An apparent 16-foot long semicircular surficial sloughing zone (Photographs 21 to 23) and several minor sloughing areas and scarps near the crest (Photograph 18, 19, 20, and 24 to 27) were observed on the west embankment.

Photo 25: Ash Pond – West embankment exterior slope, sloughing near crest of embankment, looking east.

Erosion rills and scarps – Erosion rills and scarps were observed on the exterior and interior slopes of the west embankment. Structural fill should be placed and compacted in the rills and scarps and the repaired areas graded to meet the adjacent existing contours. After slope restoration, it is recommended that the exposed surface of the embankment be stabilized with sod, or hydro seeding to restore vegetation cover on the face of the slopes.

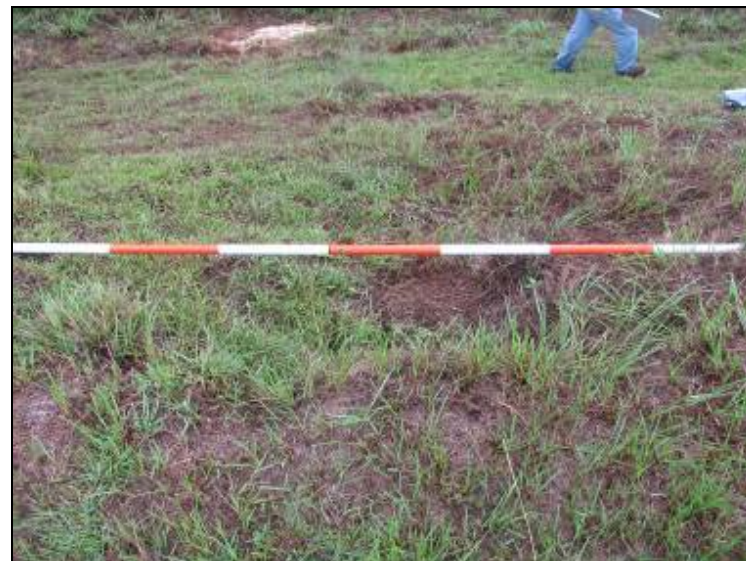
Photo 26: Ash Pond – West embankment exterior slope, sloughing near crest, looking west.

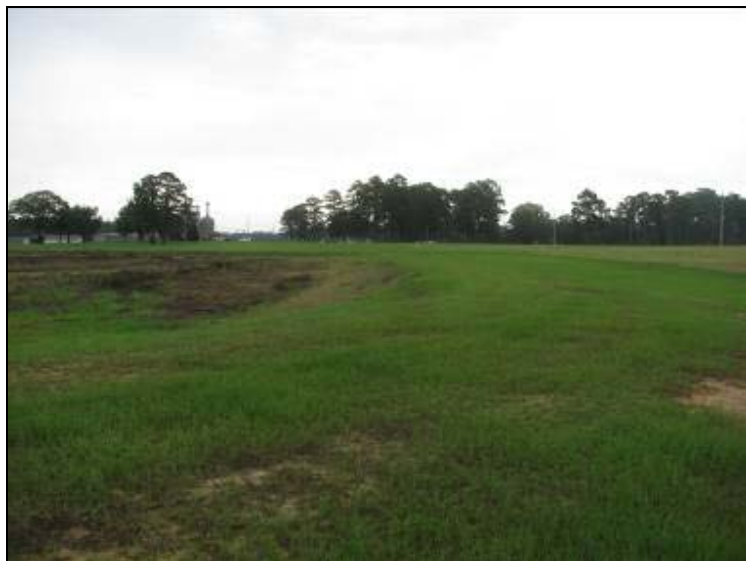
The crest of the perimeter embankments appeared to be in **SATISFACTORY** condition (Photographs 1, 34, 37, 40, 41, 46, 48 and 58). The crest width varies from about 15 and 20 feet. The crest of the embankments has a grass cover that was about 4 to 6 inches high. Reportedly, the crest is exposed to very limited vehicle traffic, only during maintenance operations. No signs of cracks, erosion, scarps, depressions or evidence of settlement were observed on the crest of any of the embankments.

Photo 37: Ash Pond – Crest of South embankment looking east.

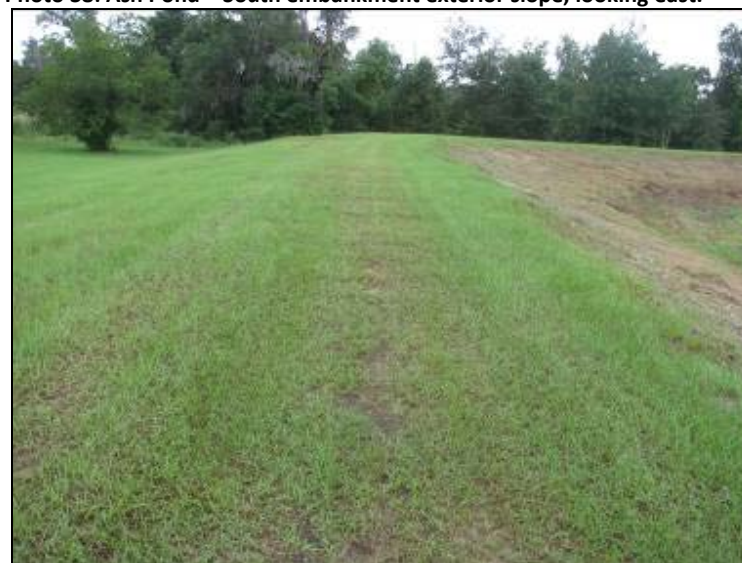
Photo 40: Ash Pond – Crest of south embankment looking west.

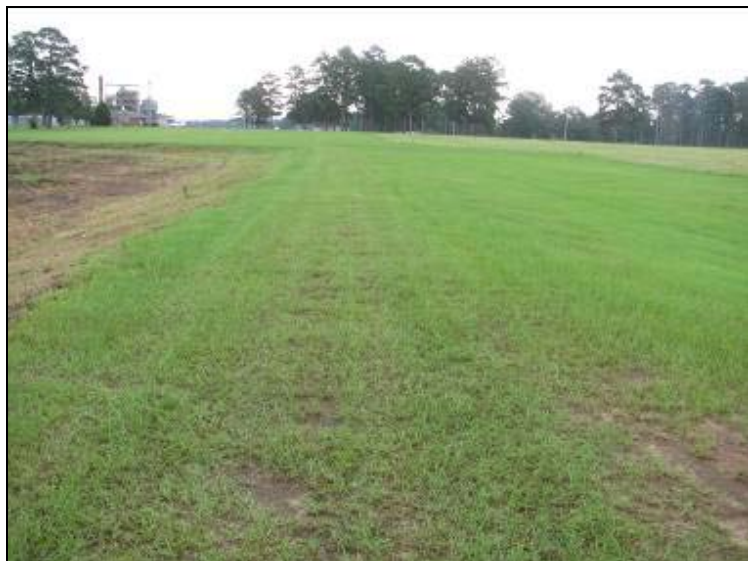
Photo 41: Ash Pond – Crest South Embankment looking east.

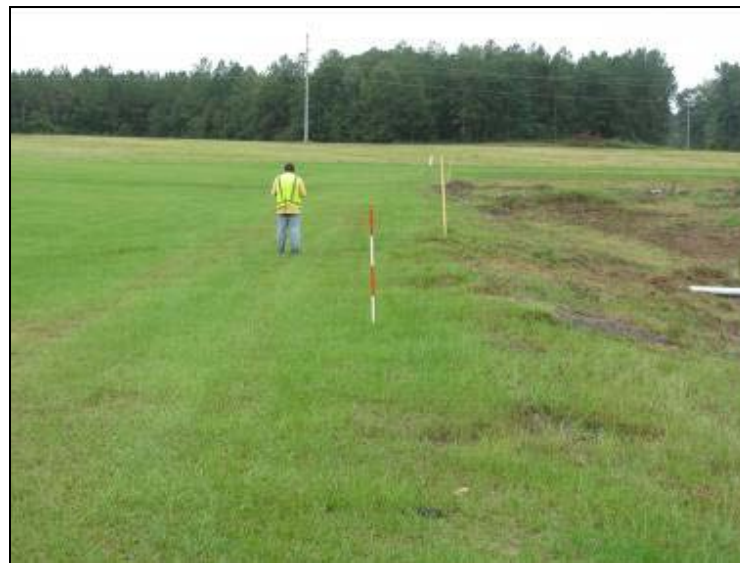
Photo 58: Ash Pond – Crest of southeast embankment near northeast corner, looking southwest.

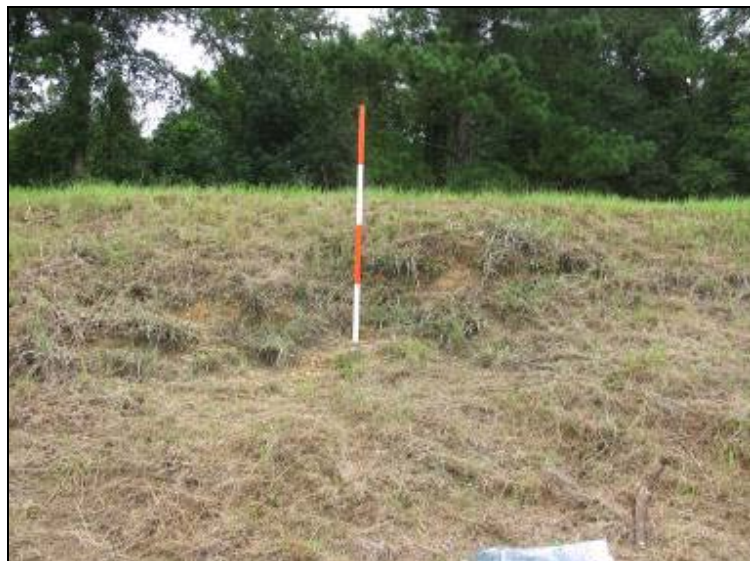
Photo 61: Ash Pond – North embankment interior slope surficial erosion, looking north.

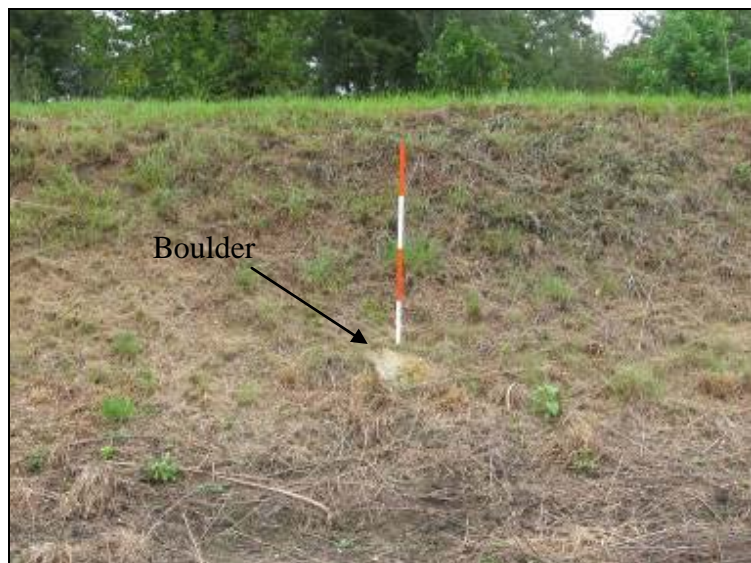
Photo 65: Ash Pond – North embankment interior slope, looking north.
Note: boulder (12"-24") and steepness of slope (2H:1V).

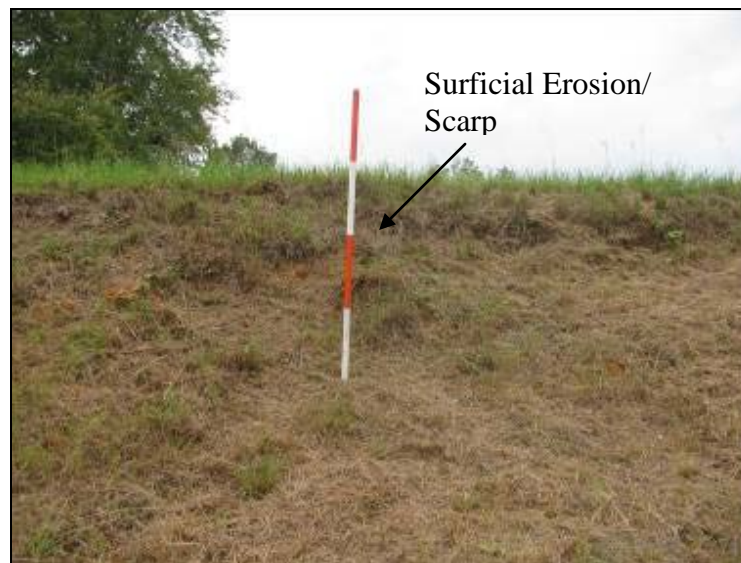
Photo 70: Ash Pond – West embankment interior slope surficial erosion/scarp, looking west.
